**STRUCTURAL DESIGN FOR FUEL CONTAINMENT
UNDER SURVIVABLE CRASH CONDITIONS**

General Dynamics | Convair, San Diego, Calif.

138P
FEDERAL AVIATION AGENCY

Technical Report ADS-19

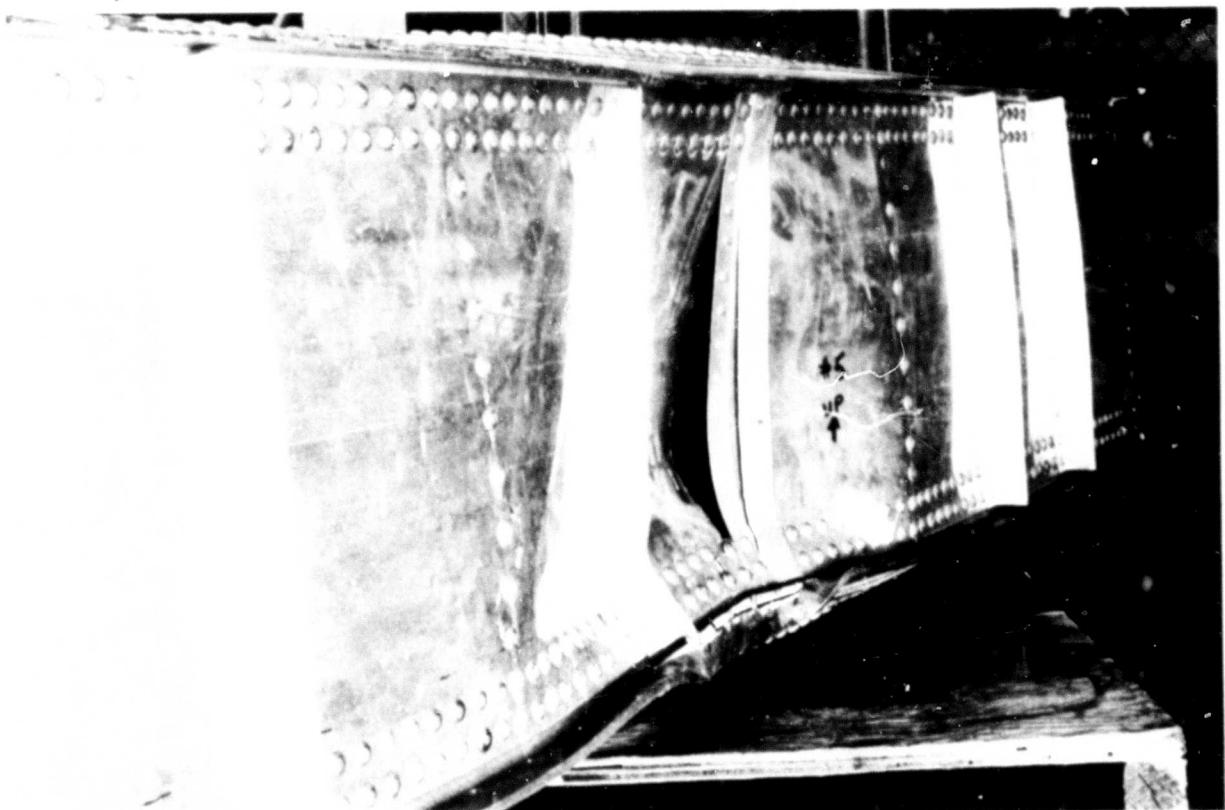
Figure B-32. Front Spar of Tank No. 5. Result of Drop 25, most fuel leakage was from this fracture.

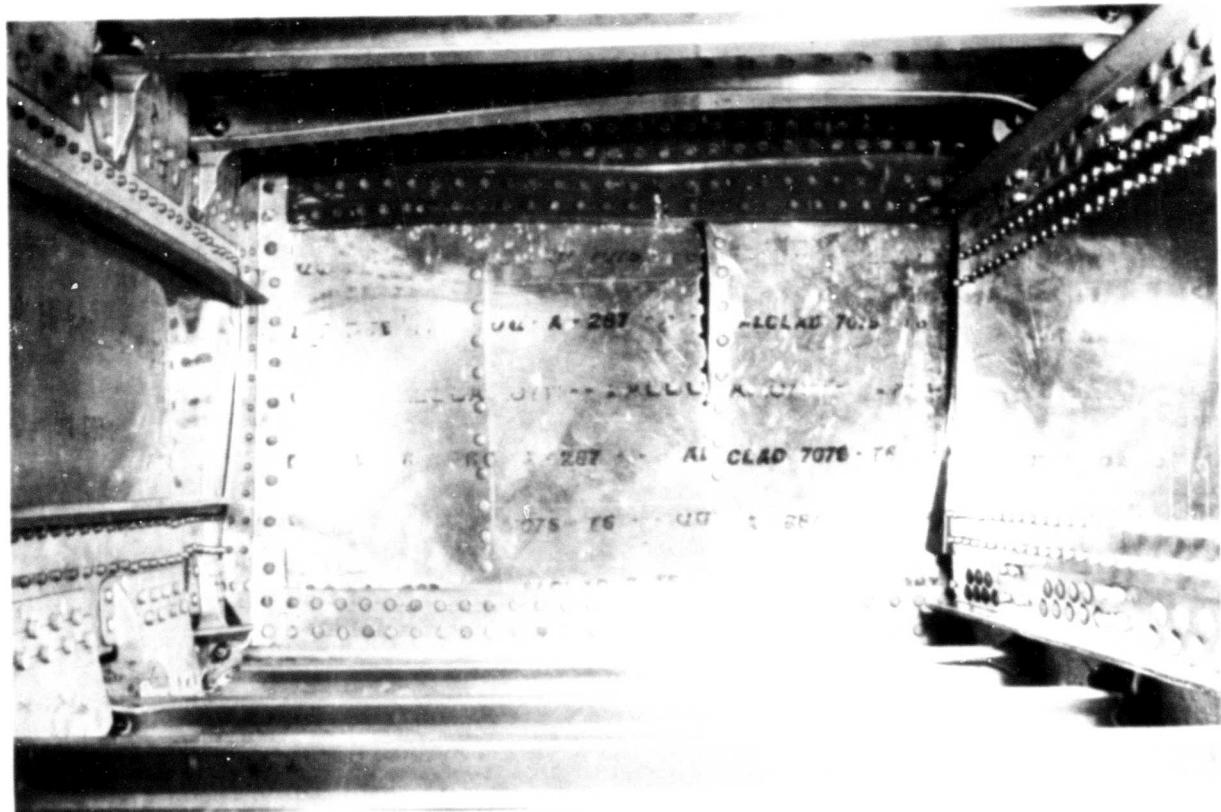
Figure B-33. Front Spar Failure of Tank No. 5. Internal view of damage shown in Figure B-32.

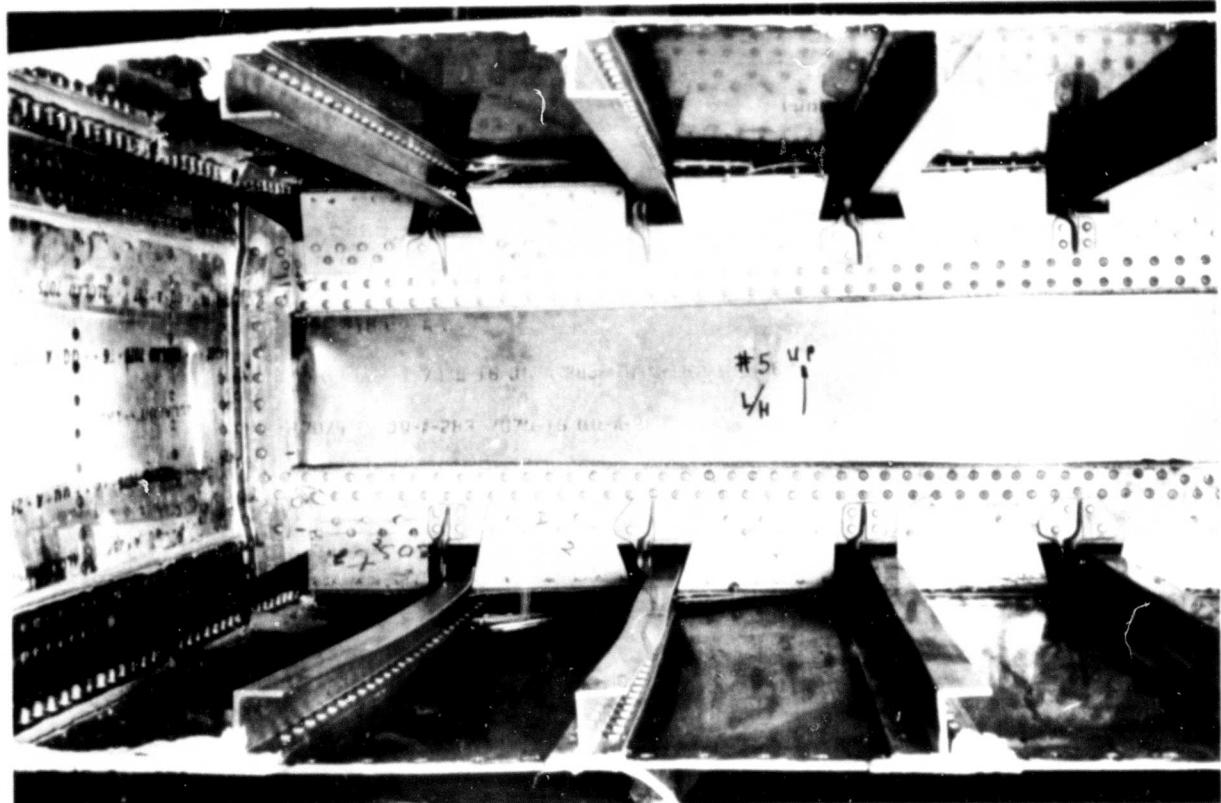
Figure B-34. Internal Damage to Tank No. 5. Results of Drop 25, log impact test, max. impact load was 97,000 lb.

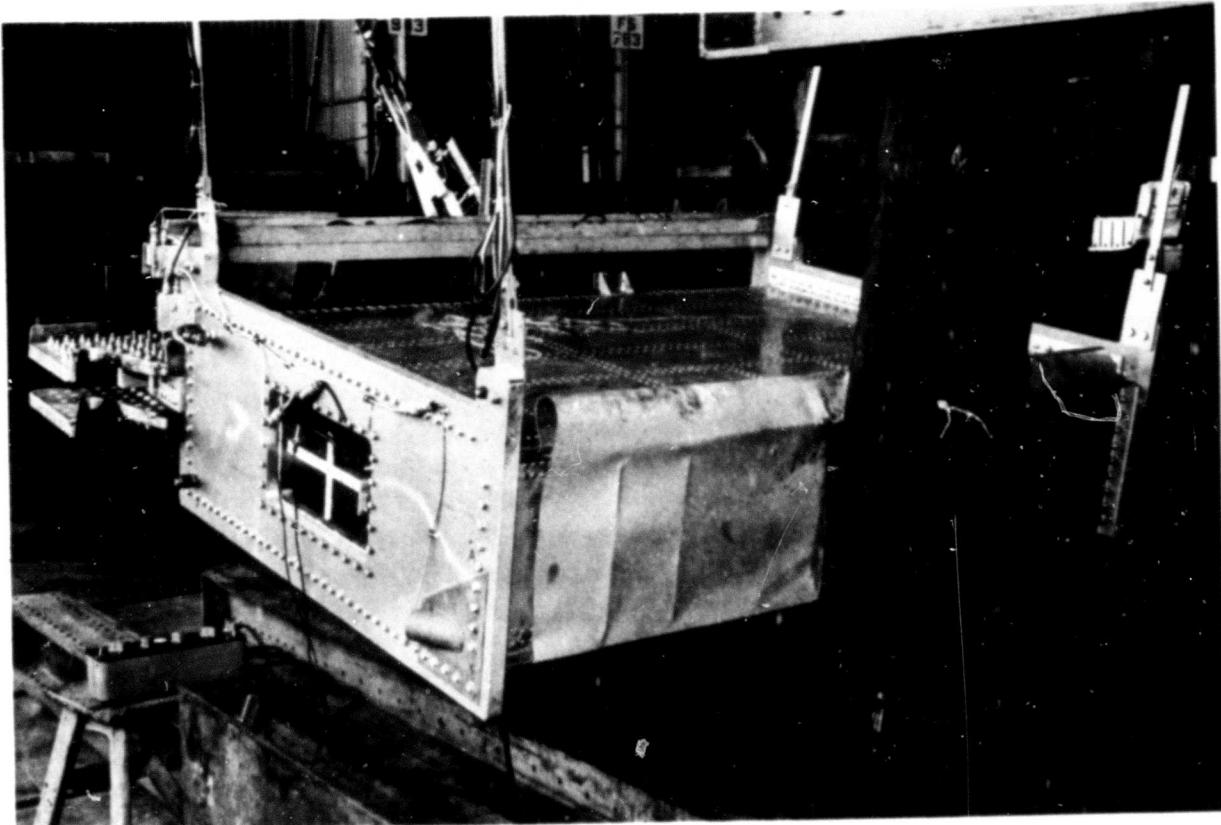
Figure B-35. Test Tank No. 6. Tank is shown prior to Drop 47 after sustaining a series of sand and sand-rock pile tests and after having broken several poles. This tank eventually broke a 17.4-in. diameter piling.

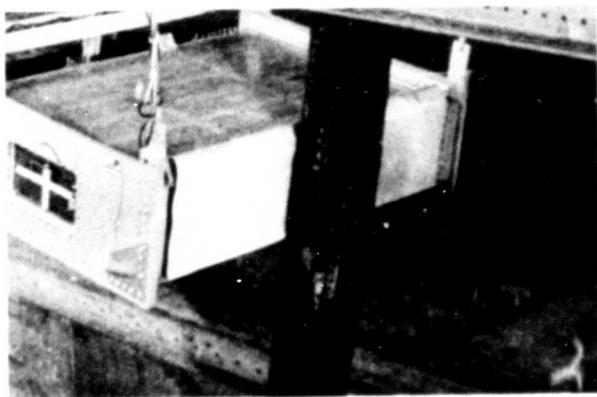
Figure B-36. Drop No. 39. Tank No. 6, 30-degree sand/rock pile, 40.1-fps impact velocity.

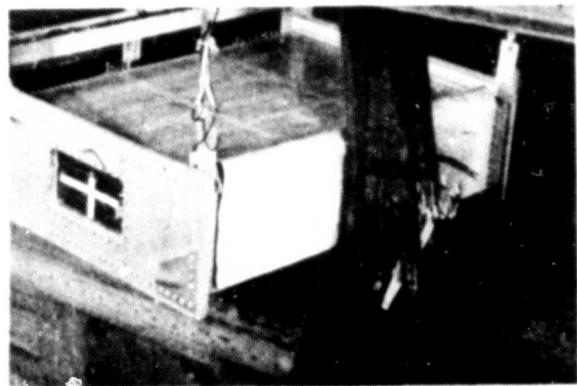
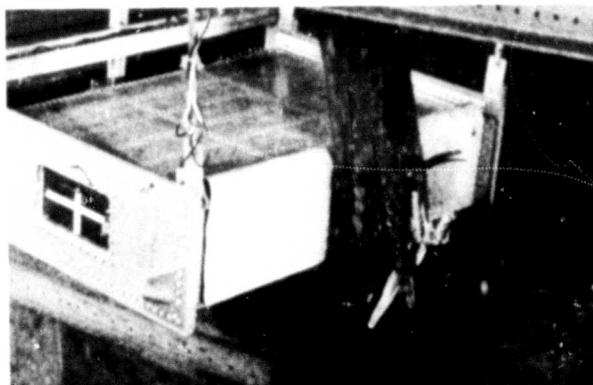
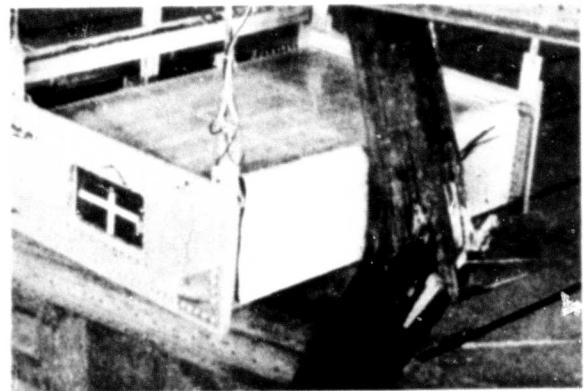
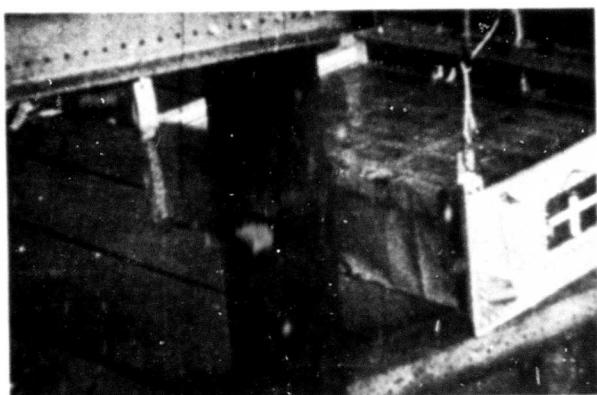
Figure B-37. Drop No. 50. Tank No. 6, 16-in. diameter pole, 41-6 fps impact velocity.

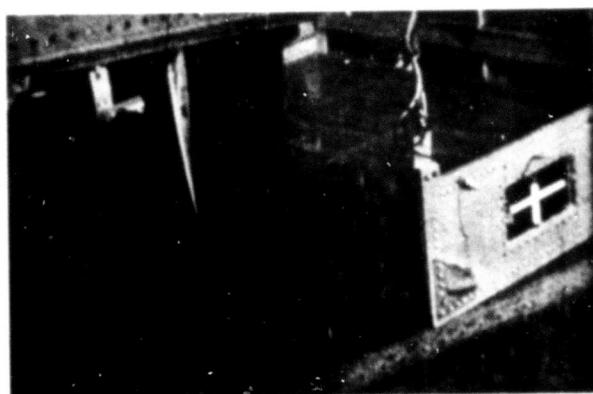
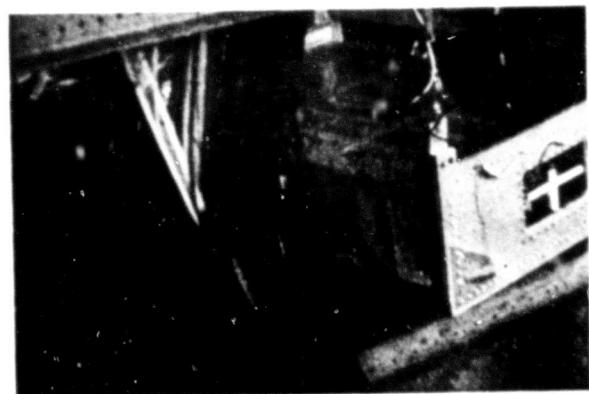
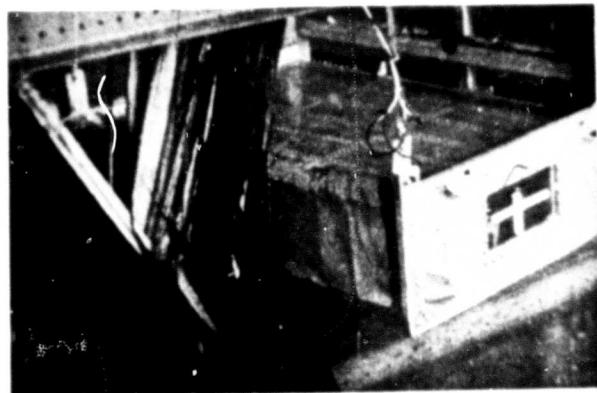
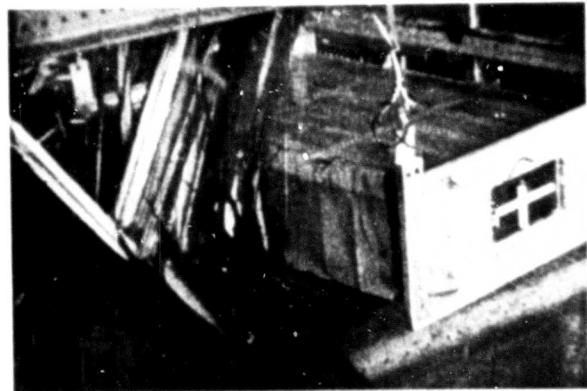
Figure B-38. Drop No. 52. Tank No. 6, 17.4-in. diameter piling, 47.4-fps impact velocity.

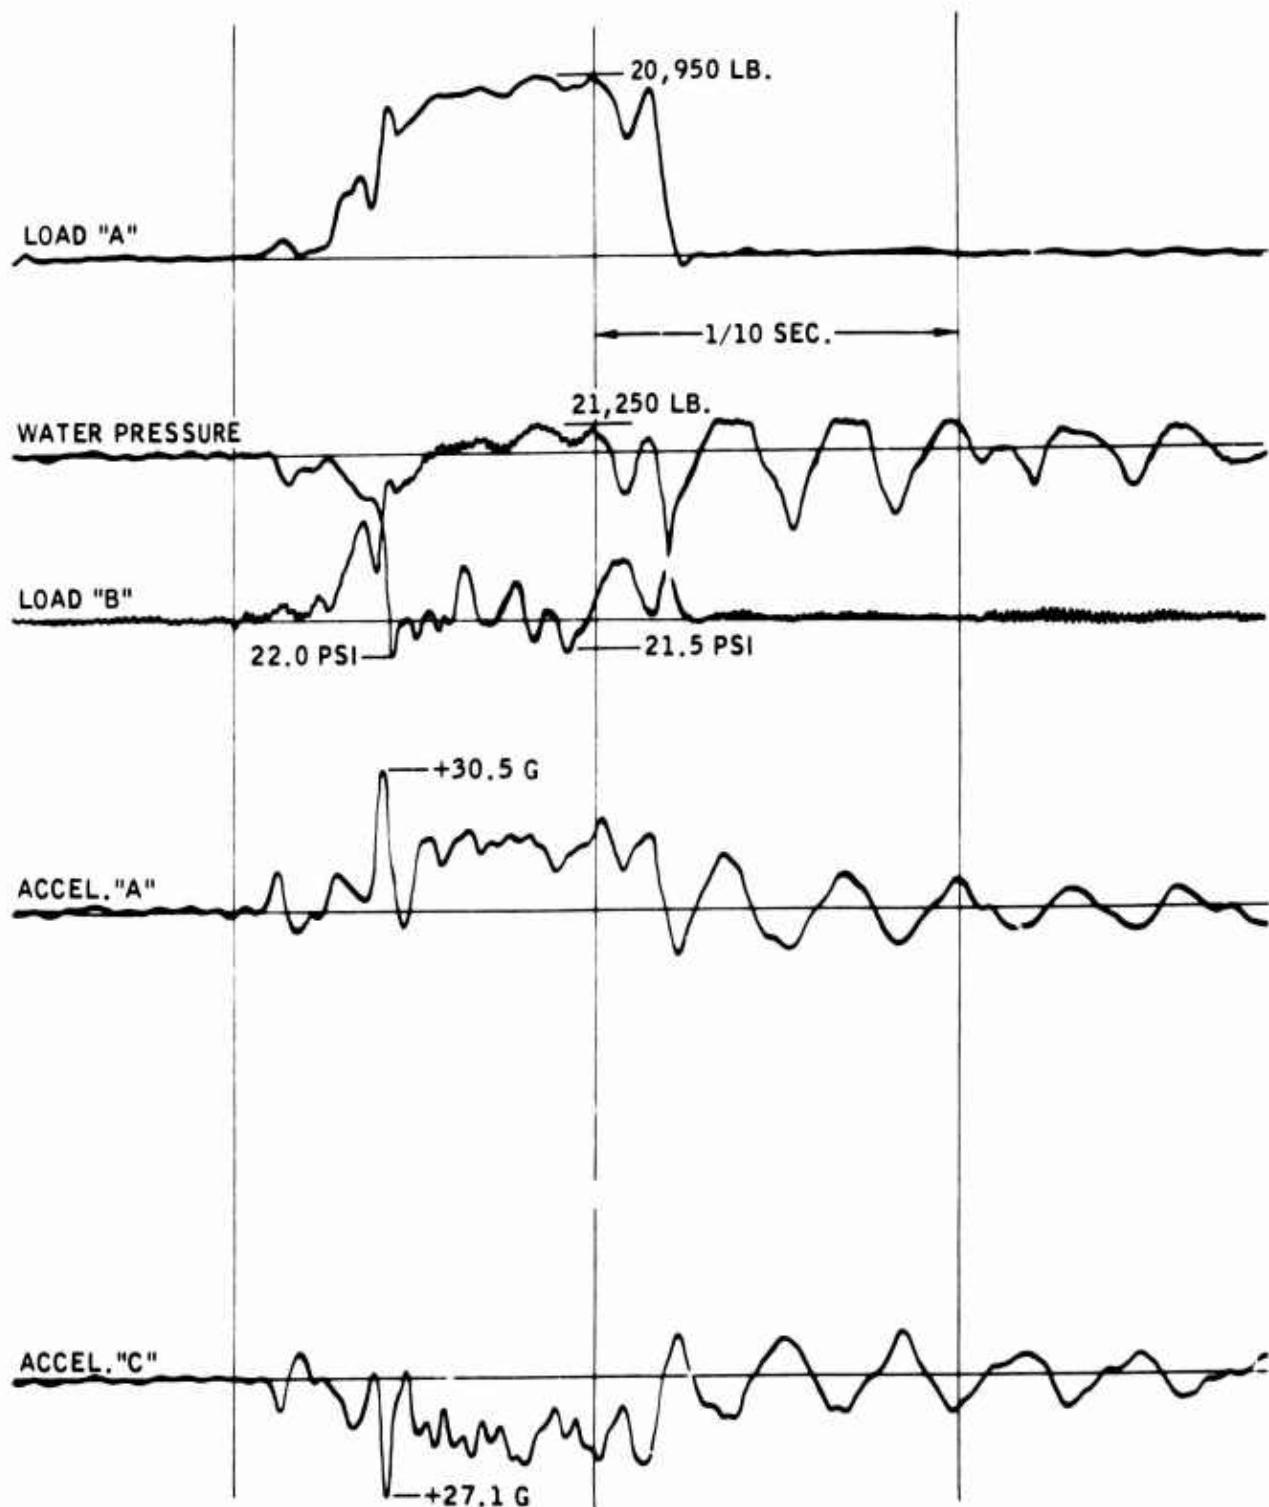
Figure B-41. Drop No. 11, 15-ft. Arrested

1	2	3	4	5	6	7	8	9	10	11	12
Drop No.	Tank No.	Type Test	Drop Height (ft.)	Drop Weight (lb.)	Impact Velocity (fps)	Peak Load (lb.)	Load Accel. A	Peak G	Accel. C	Peak Pressure (psi)	Damage
1	1	Arrested	5	2,784	17.9	24,220	8.7	--	--	7.4	No damage
2	1	Arrested	10	2,784	25.4	20,670	Arresting Straps Broke		8.1	Internal damage	
3	1	Arrested	15	2,784	31.0	48,800	17.5	--	--	22.6	Internal damage
4	1	Log Impact	10	2,784	25.4	34,100	12.2	14.4	--	19.6	Tank ruptured
5	2	Arrested	10	2,802	25.4	30,820	11.0	19.6	--	13.1	No damage
6	2	Log Impact	2	2,580	11.3	35,410	13.7	22.0	--	20.1	Internal damage
7	2	Log Impact	3	2,575	13.9	40,450	15.7	33.1	--	30.5	Internal damage
8	2	Log Impact	4	2,570	16.0	48,080	18.7	32.7	--	29.1	Perm. set in F. Spar
9	2	Log Impact	5	2,565	17.9	52,440	20.4	30.6	--	28.7	Perm. set in F. Spar
10	2	Log Impact	6	2,560	19.6	52,710	20.6	30.0	--	26.8	Tank ruptured
11	3	Arrested	15	2,780	31.0	42,240	15.2	30.5	27.4	22.0	Internal damage

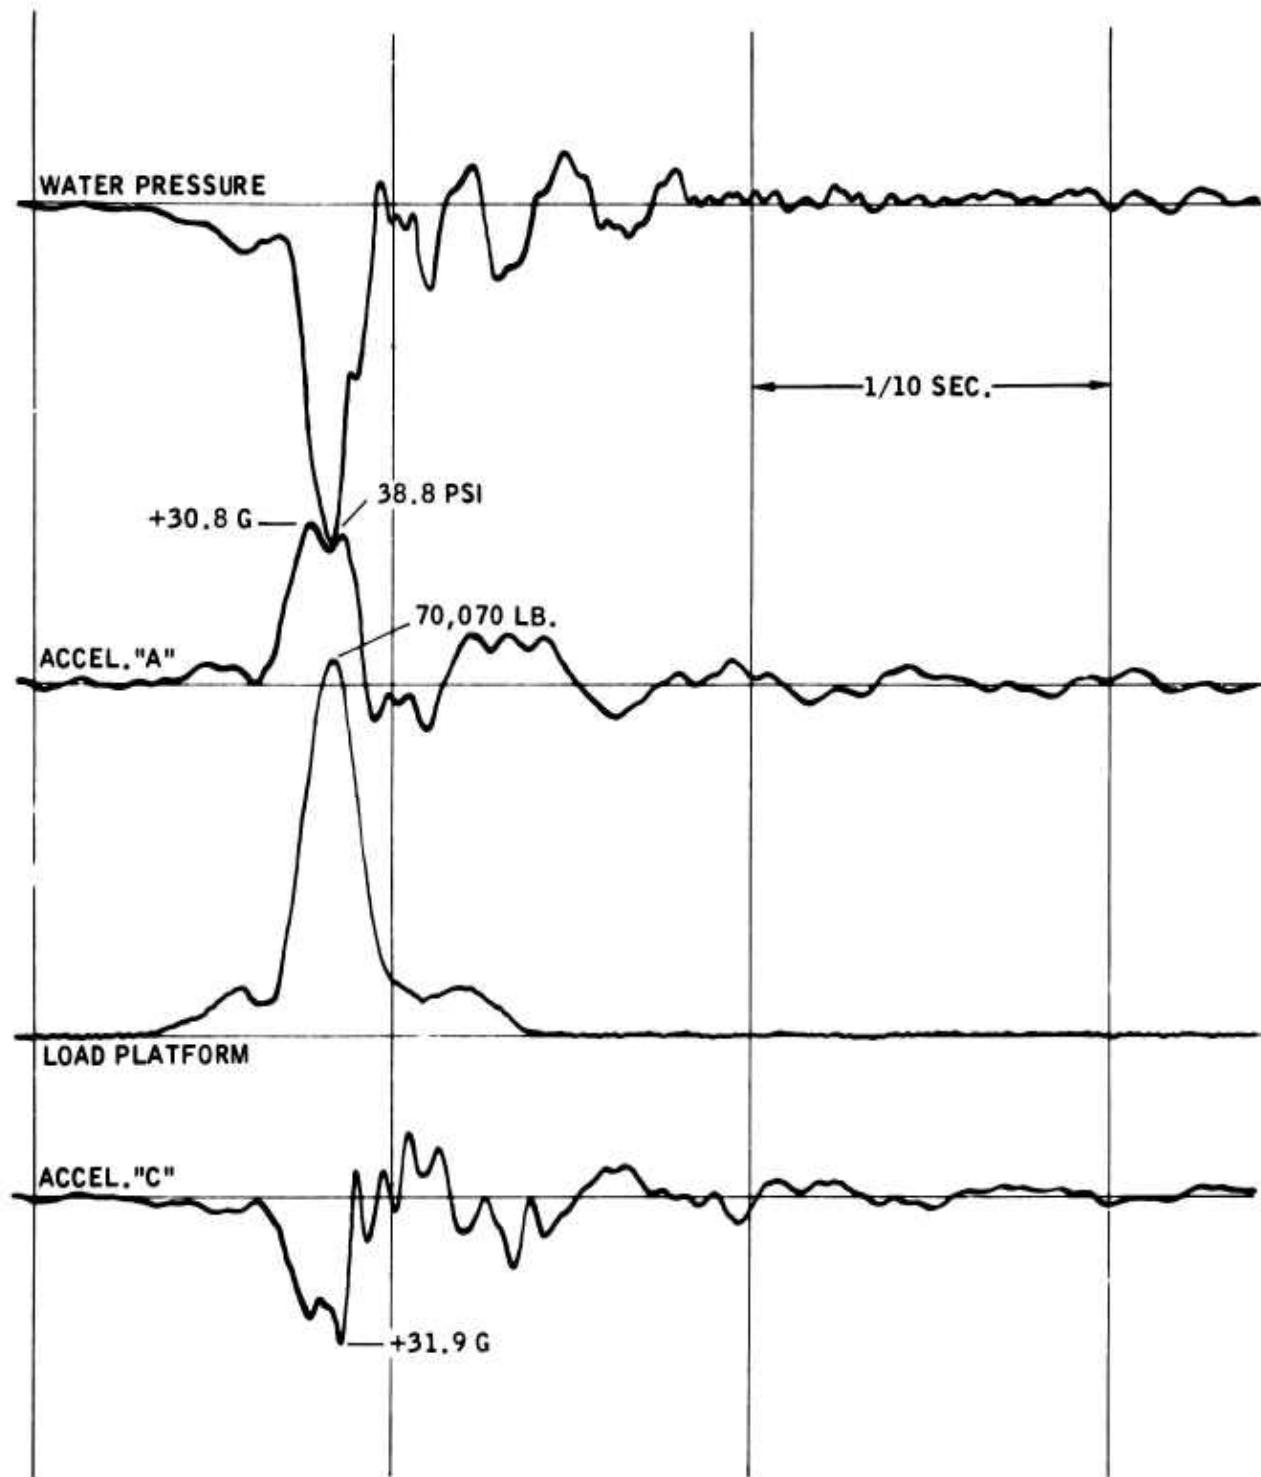
Figure B-42. Drop No. 12, 5-ft. Log Impact

12	3	Log Impact	5	2,558	17.9	70,070	27.4	30.8	31.9	38.8	Upper skin cracks
13	4	Arrested	15	1,834 (1/2 full)	31.0	25,240	13.8	24.9	27.0	19.0	No damage
14	4	Log Impact	3	1,612 (1/2 full)	13.9	33,100	20.5	38.3	35.2	6.3	No damage

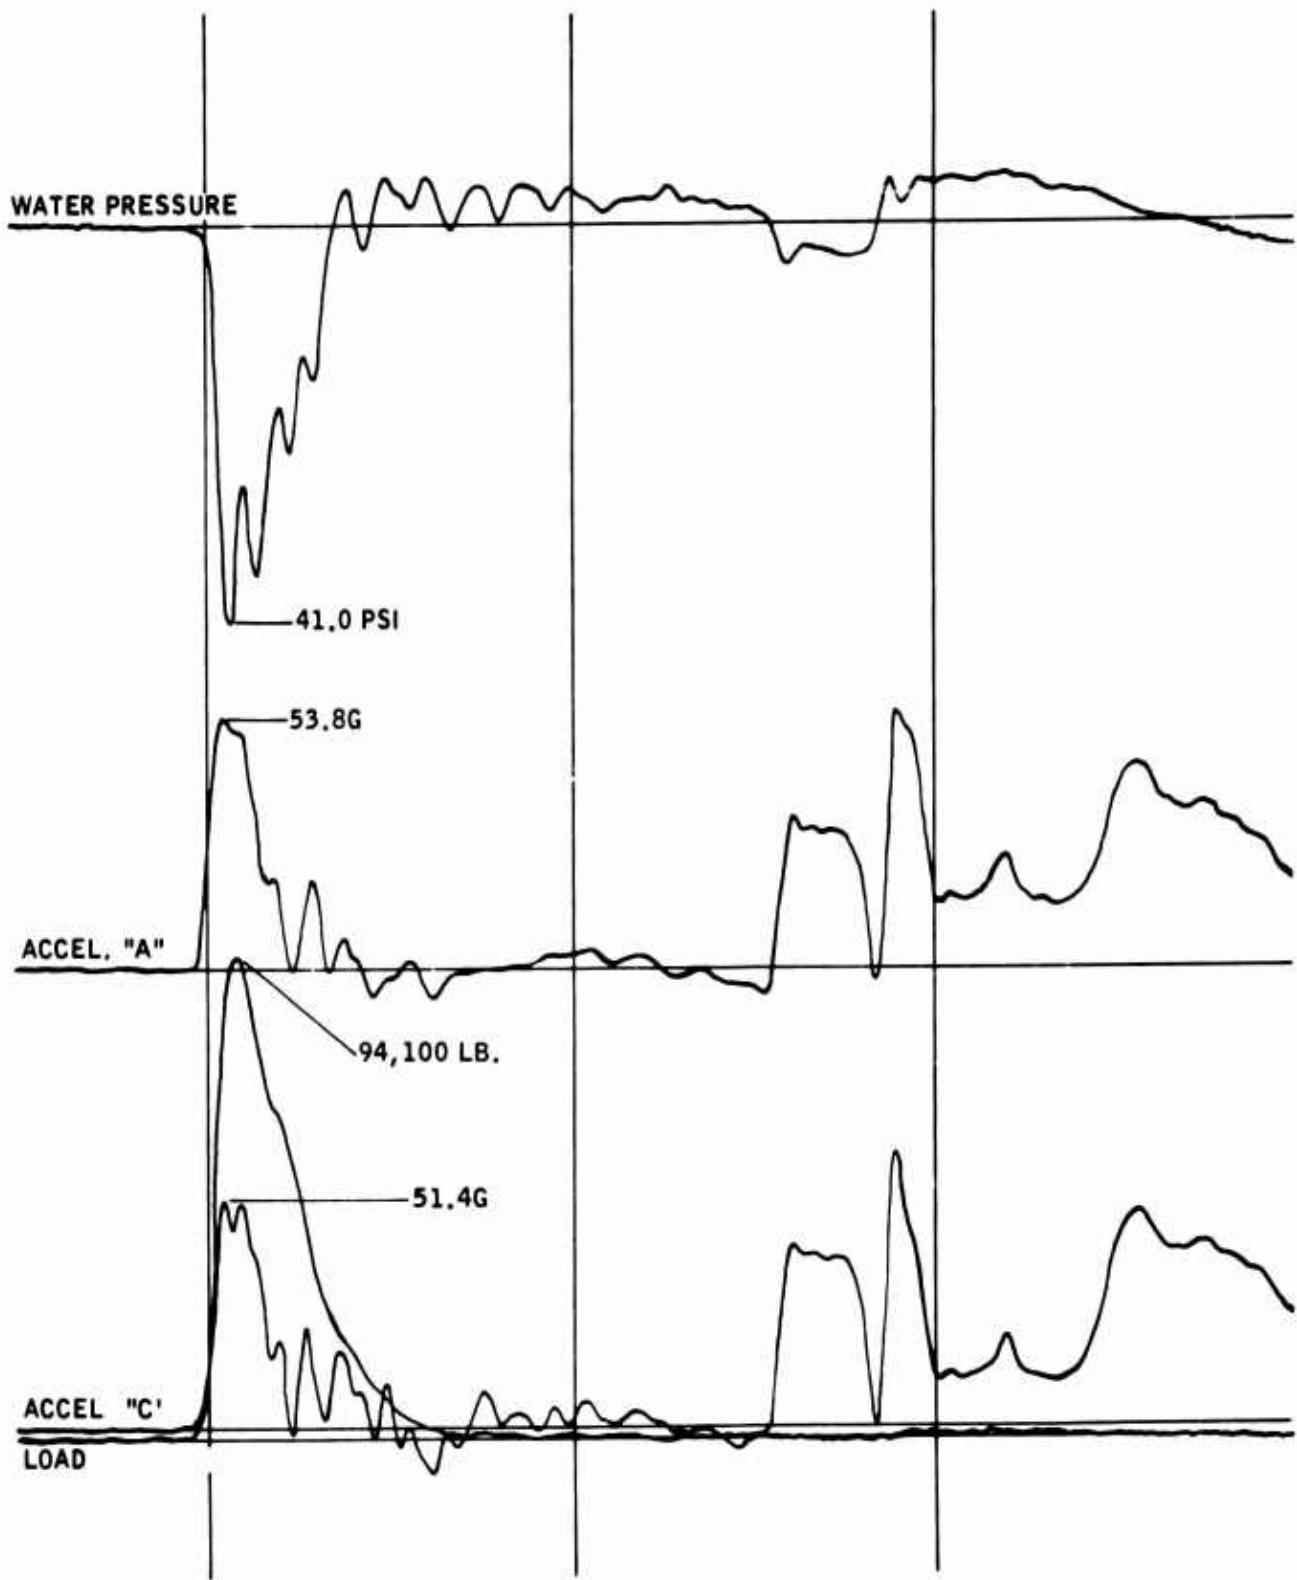
Figure B-45. Drop No. 21, 9-ft. Log Impact

Note 2. Figure B-24 shows progressive skin failure resulting from three successive drop tests. Drop No. 19 caused cracks approximately 2 in. long at the aft end of the intercostals supporting the third skin bay. Drop No. 20 extended the cracks somewhat and Drop No. 21 extended the cracks from tip to tip.

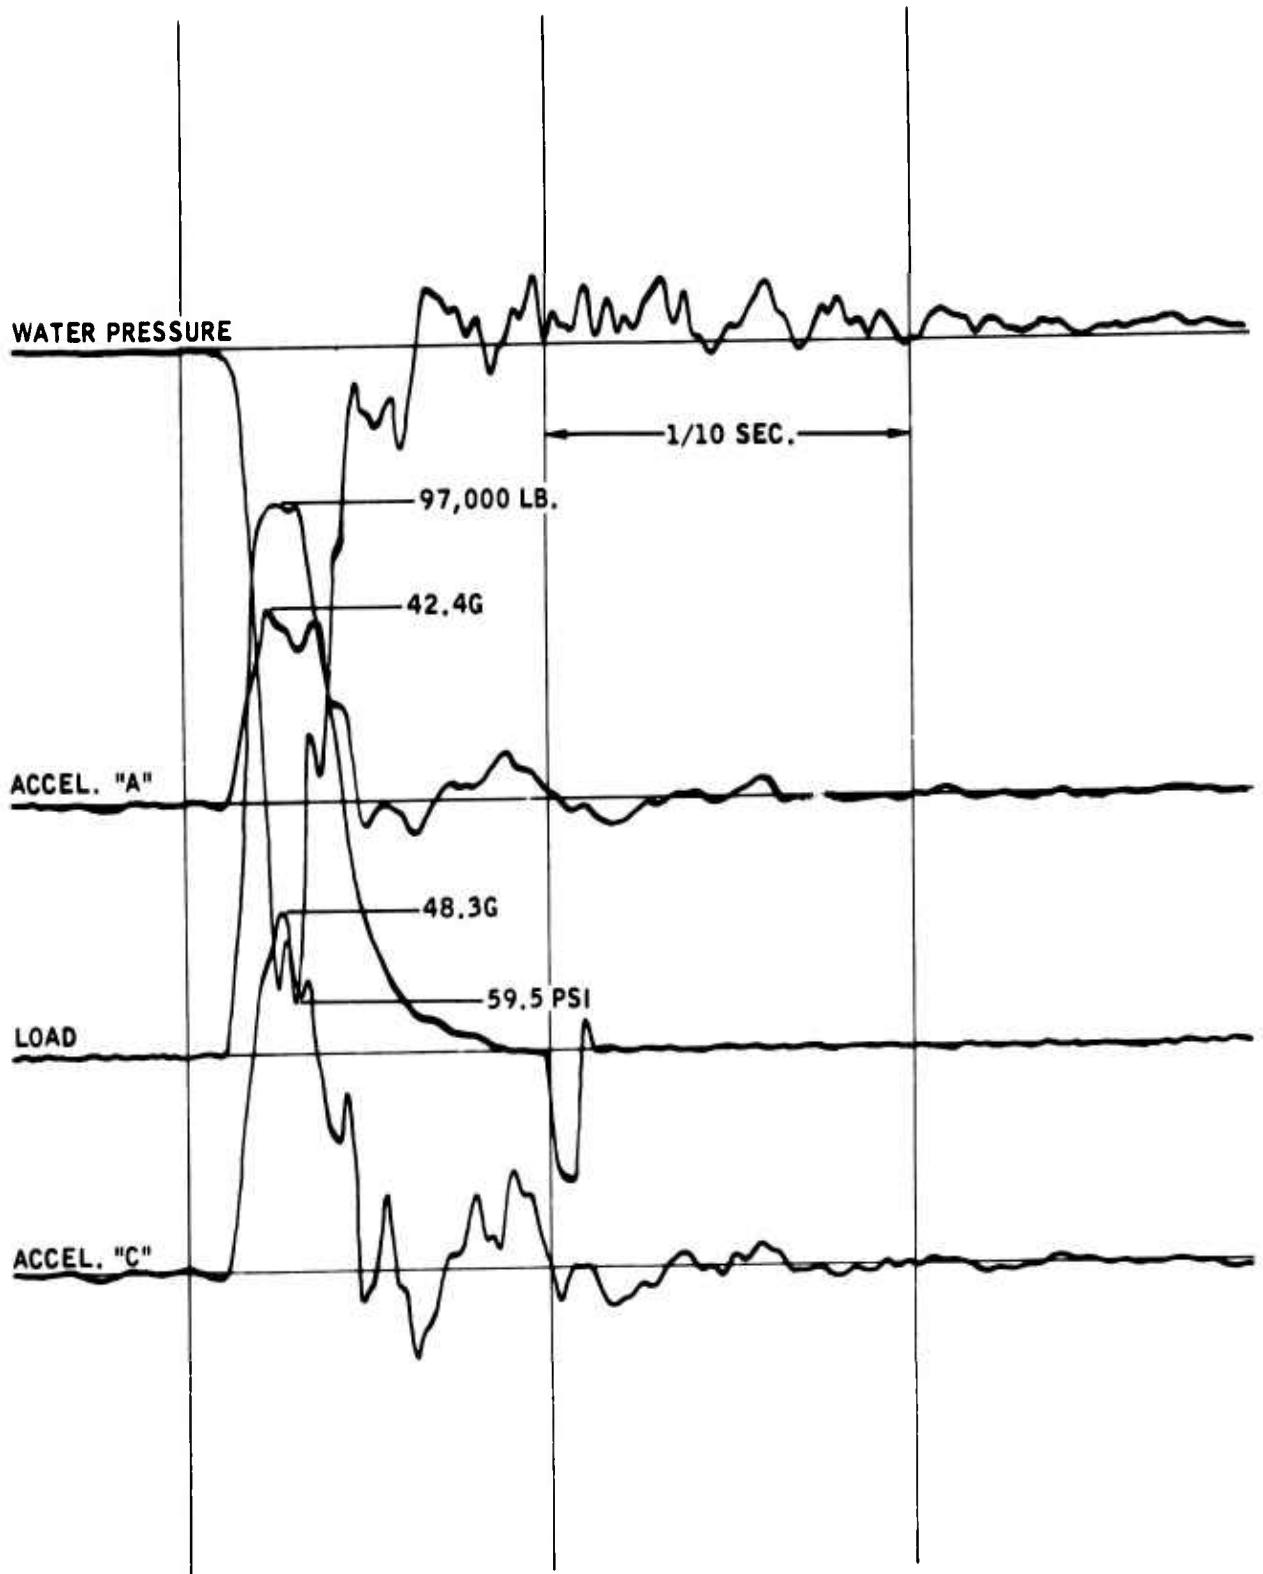
Figure B-46. Drop No. 25, 12-ft. Log Impact

1	2	3	4	5	6	7	8	9	10	11	12
Drop No.	Tank No.	Type Test	Drop Height (ft.)	Drop Weight (lb.)	Impact Velocity (fps)	Peak Load (lb.)	Peak g	Load Accel. A	Accel. C	Peak Pressure (psi)	Damage
15	4	Log Impact	3	2,089 (3/4 full)	13.9	41,600	19.9	36.0	36.2	12.5	No damage
16	4	Log Impact	3	2,570	13.9	60,100	23.4	25.6	19.0	40.6	Internal damage
17	4	Arrested	26	2,790	40.9	74,300	26.6	35.2	33.6	34.7	Internal damage
18	4	Arrested	36.33	2,790	48.4	97,600	35.0	44.8	45.9	45.4	Note 1
19	4	Log Impact	5	2,590	17.9	70,200	27.1	40.9	40.9	28.3	Note 2
20	4	Log Impact	7	2,590	21.2	84,700	32.7	49.0	52.1	35.8	Note 2
21	4	Log Impact	9	2,570	24.0	94,100	36.6	53.8	51.4	41.0	Note 2
22	5	Arrested	30	2,316 (3/4 full)	44.0	35,740	15.4	25.7	27.8	35.6	No damage
23	5	Log Impact	10	2,316 (3/4 full)	25.4	89,680	38.7	56.4	68.8	25.6	No damage
24	5	Log Impact	12	2,316 (3/4 full)	27.8	97,500	42.1	58.5	70.4	33.6	Internal damage
25	5	Log Impact	12	2,786	27.8	97,000	34.8	42.4	48.3	59.5	Tank ruptured

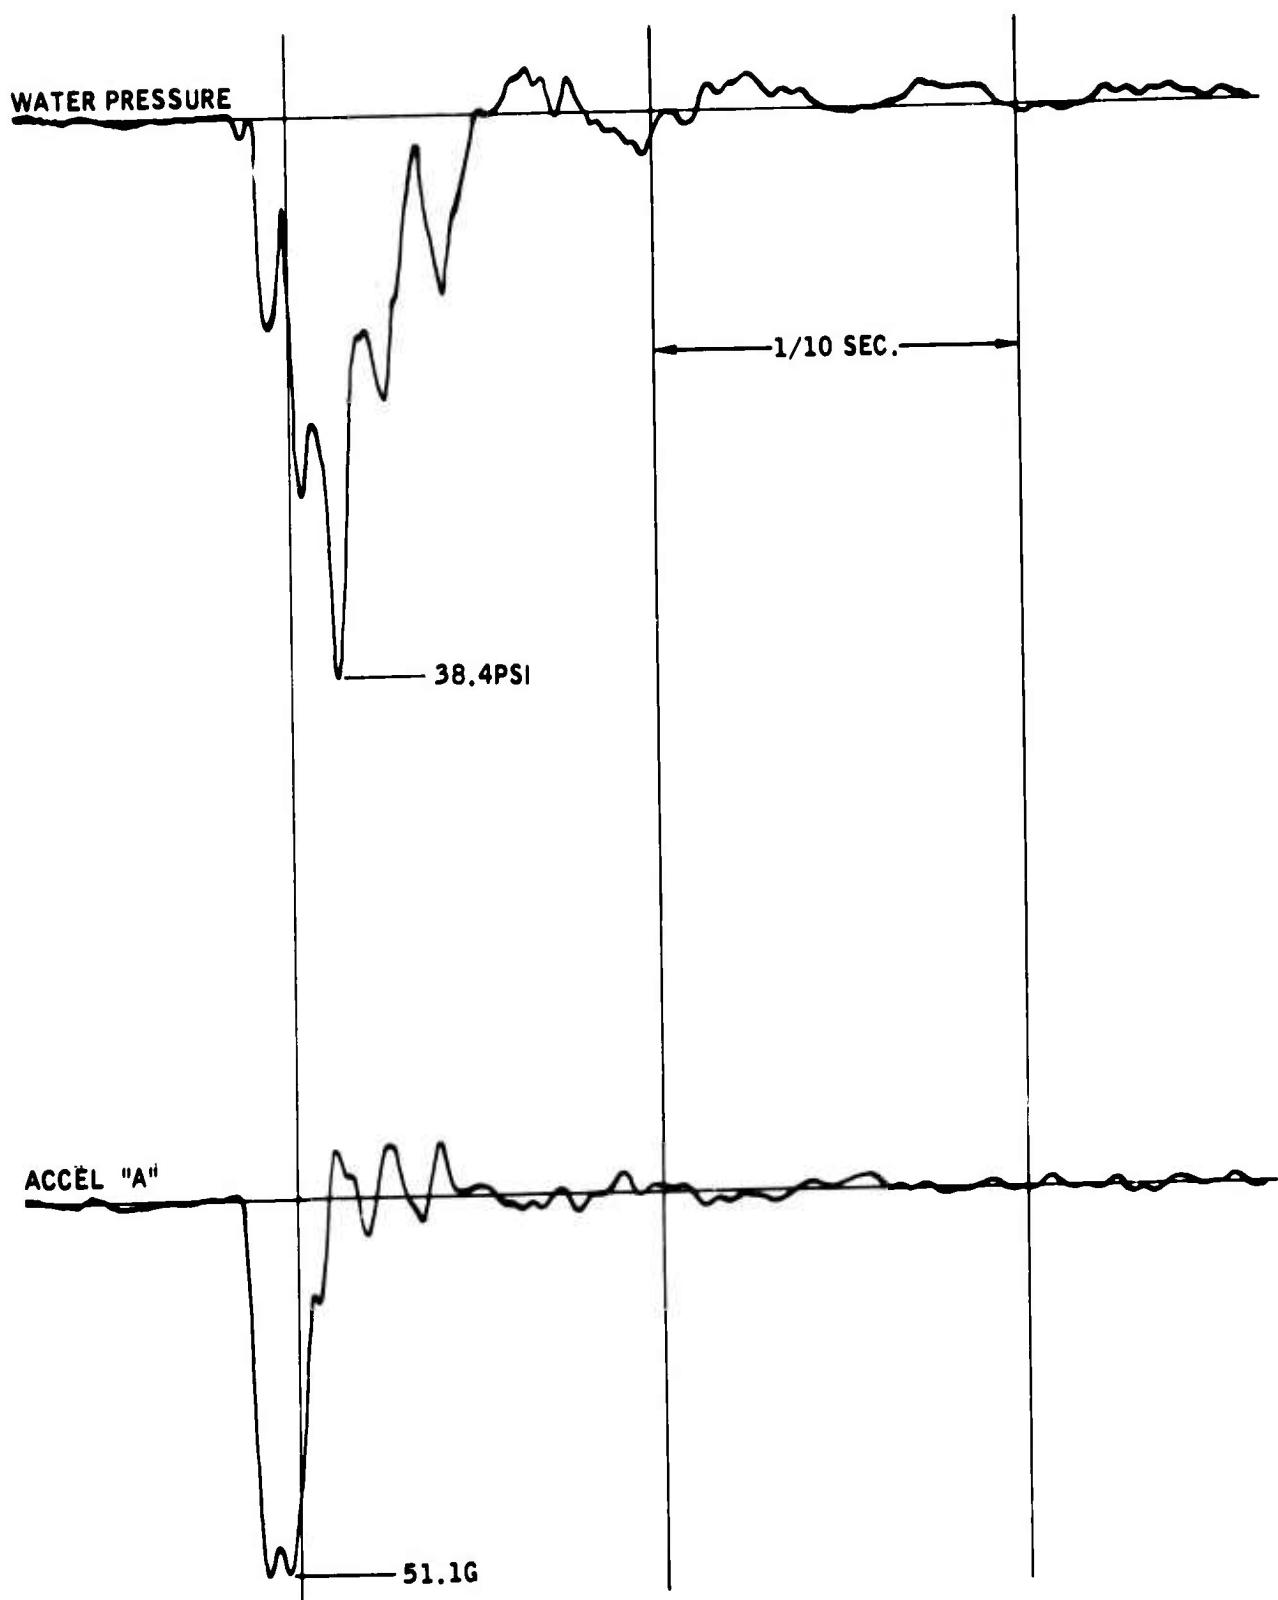
Figure B-48. Drop No. 50, 27-ft. Pole Impact, 16-in. Diameter, Tank Weight 2,830 lb.

Note 4. The outstanding leg of the most forward intercostals began to crack during Drop No. 49. The cracks progressed slowly through Drop No. 52.
